## FACILITY COMPLIANCE INSPECTION REPORT

### Division of Waste Management Solid Waste Section

**Date of Site Inspection:** December 16, 2013 **Date of Last Inspection:** October 3, 2013

Inert Disposal (Stump Dump) LCID Landfill  
1017 Center Grove Church Road  
Moncure, NC 27559

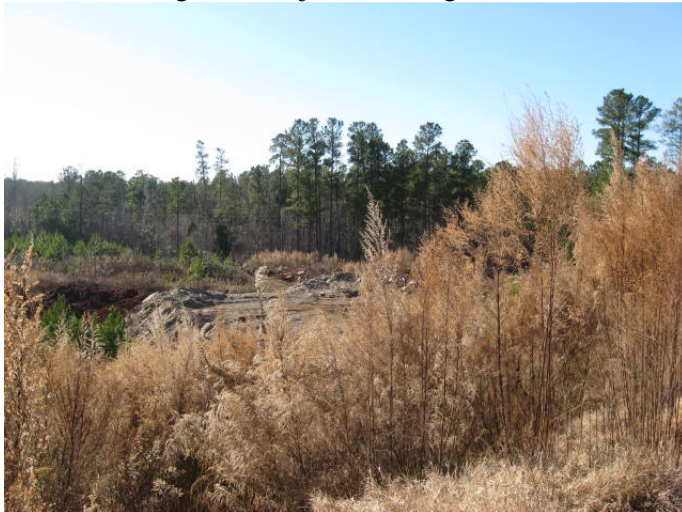
13. Ensure inert debris is located within the designated LCID landfill area, reused, recycled, and/or graded accordingly and covered with soil.
14. Per 15A NCAC 13B .0564(9)(b), "The facility shall meet the following buffer requirements: 100 feet from the disposal area to property lines, residential dwellings, commercial or public buildings, and wells."

Concrete storage area, adjacent (on right) to LCD fill area    LCD disposal area access road – view toward site entrance

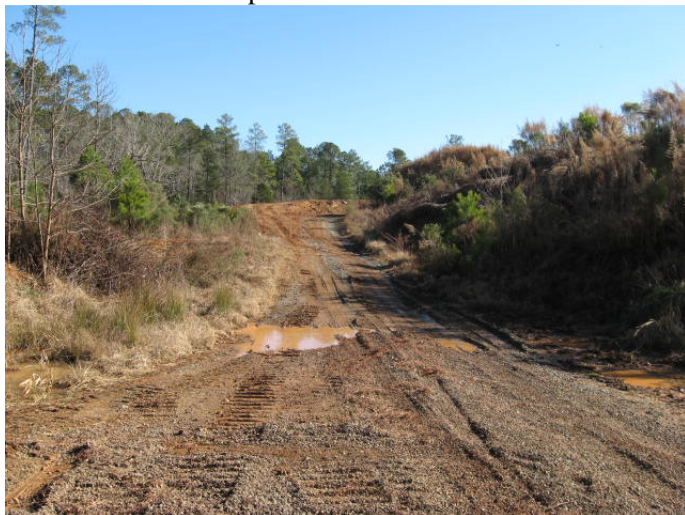
Entrance to LCD disposal area

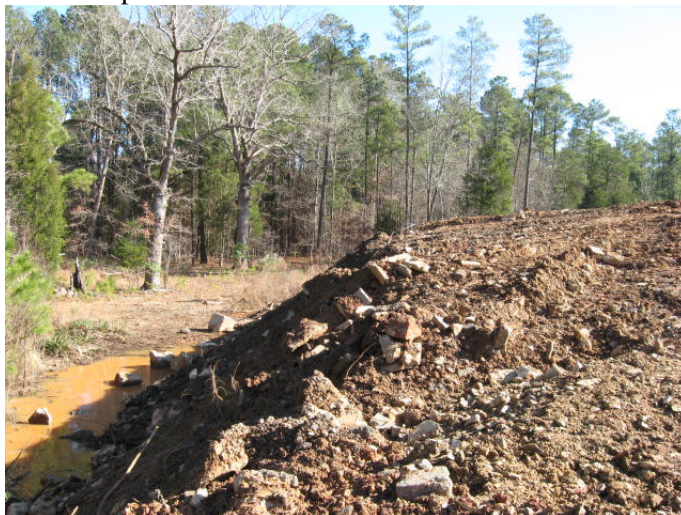
9. Side slopes should be graded and covered with soil such that a 3:1 slope ratio is obtained or a ratio of which no indication of erosion or runoff is observed.

Side slope – left front

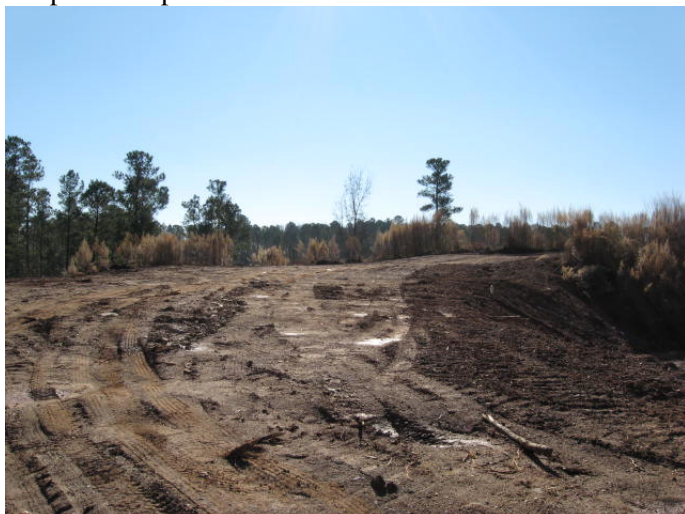
Atop side slope – left rear area

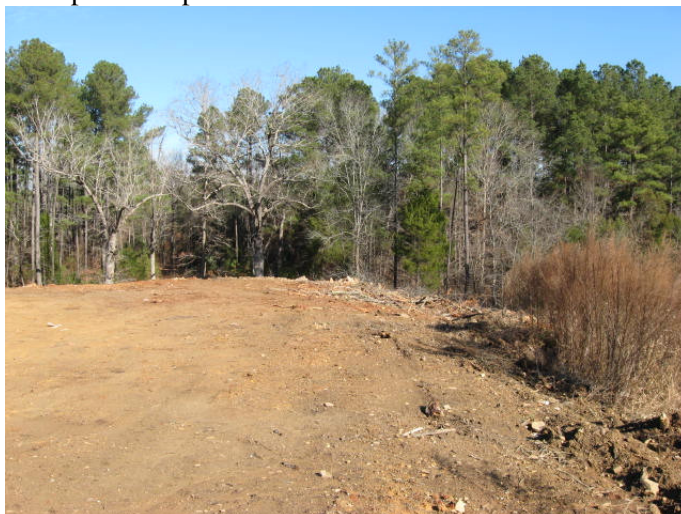
Atop side slope – center rear area

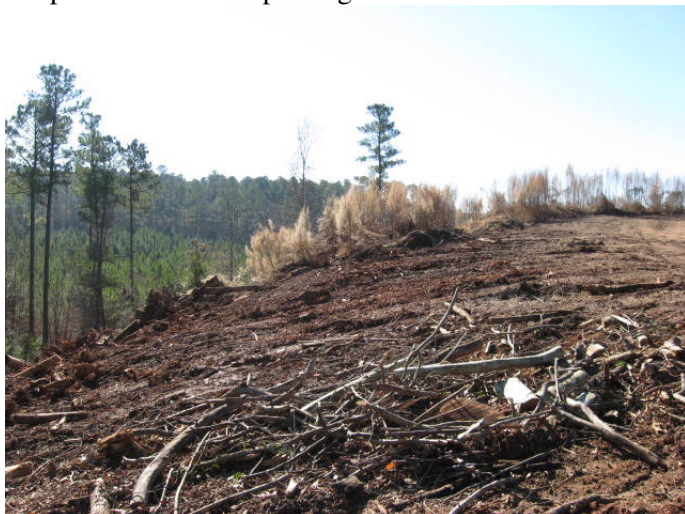
Atop external side slope – right rear area

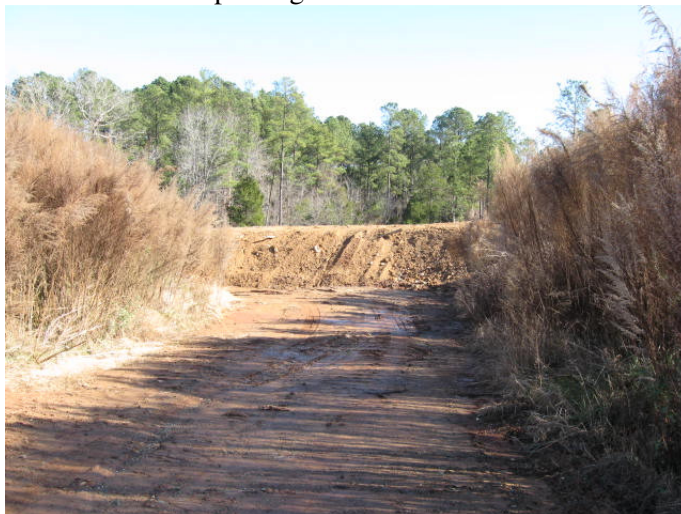
Internal side slope – right rear area
